**ROAD SAFETY AUDIT
STAGE 3**

**S278 WORKS
COMPLETED ON**

**CHERITON INTERCHANGE,
FOLKESTONE**

REPORT REF: BN-TWSE-25-142

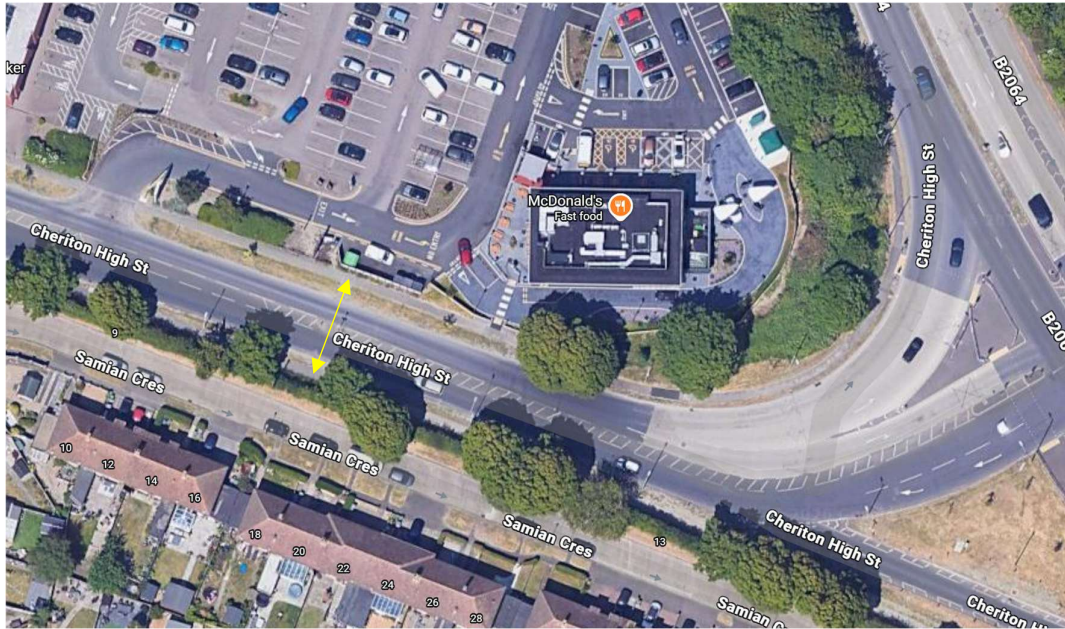
Location: D – Uncontrolled Crossing Cheriton High Street
Summary: Risk of pedestrian injury/strike within the existing uncontrolled crossing.

On-site observations noted a high number of pedestrians crossing Cheriton High Street at the location below:

This uncontrolled crossing is not fit for purpose. The central island is not wide enough to accommodate users (on site observations noted a mobility user crossing within the island which resulted in overhang of their scooter within the running lane), and high levels of standing water and a large pothole was also noted within the vicinity. With the concern due to the lack of pedestrian phase within the signalised junction alongside the existing attractors (i.e. McDonalds and Tesco) there is a concern that there is an increased risk of pedestrian strike/injury at this location.

RECOMMENDATION: It is recommended that this uncontrolled crossing is upgraded.
